**Vegetative Sampling Results Summary**  
**In Support of Health and Safety Plan**  
**For Vegetation Clearing and Grubbing**  
**West Lake Landfill Operable Unit 1, Bridgeton, Missouri**

**March 30, 2009**

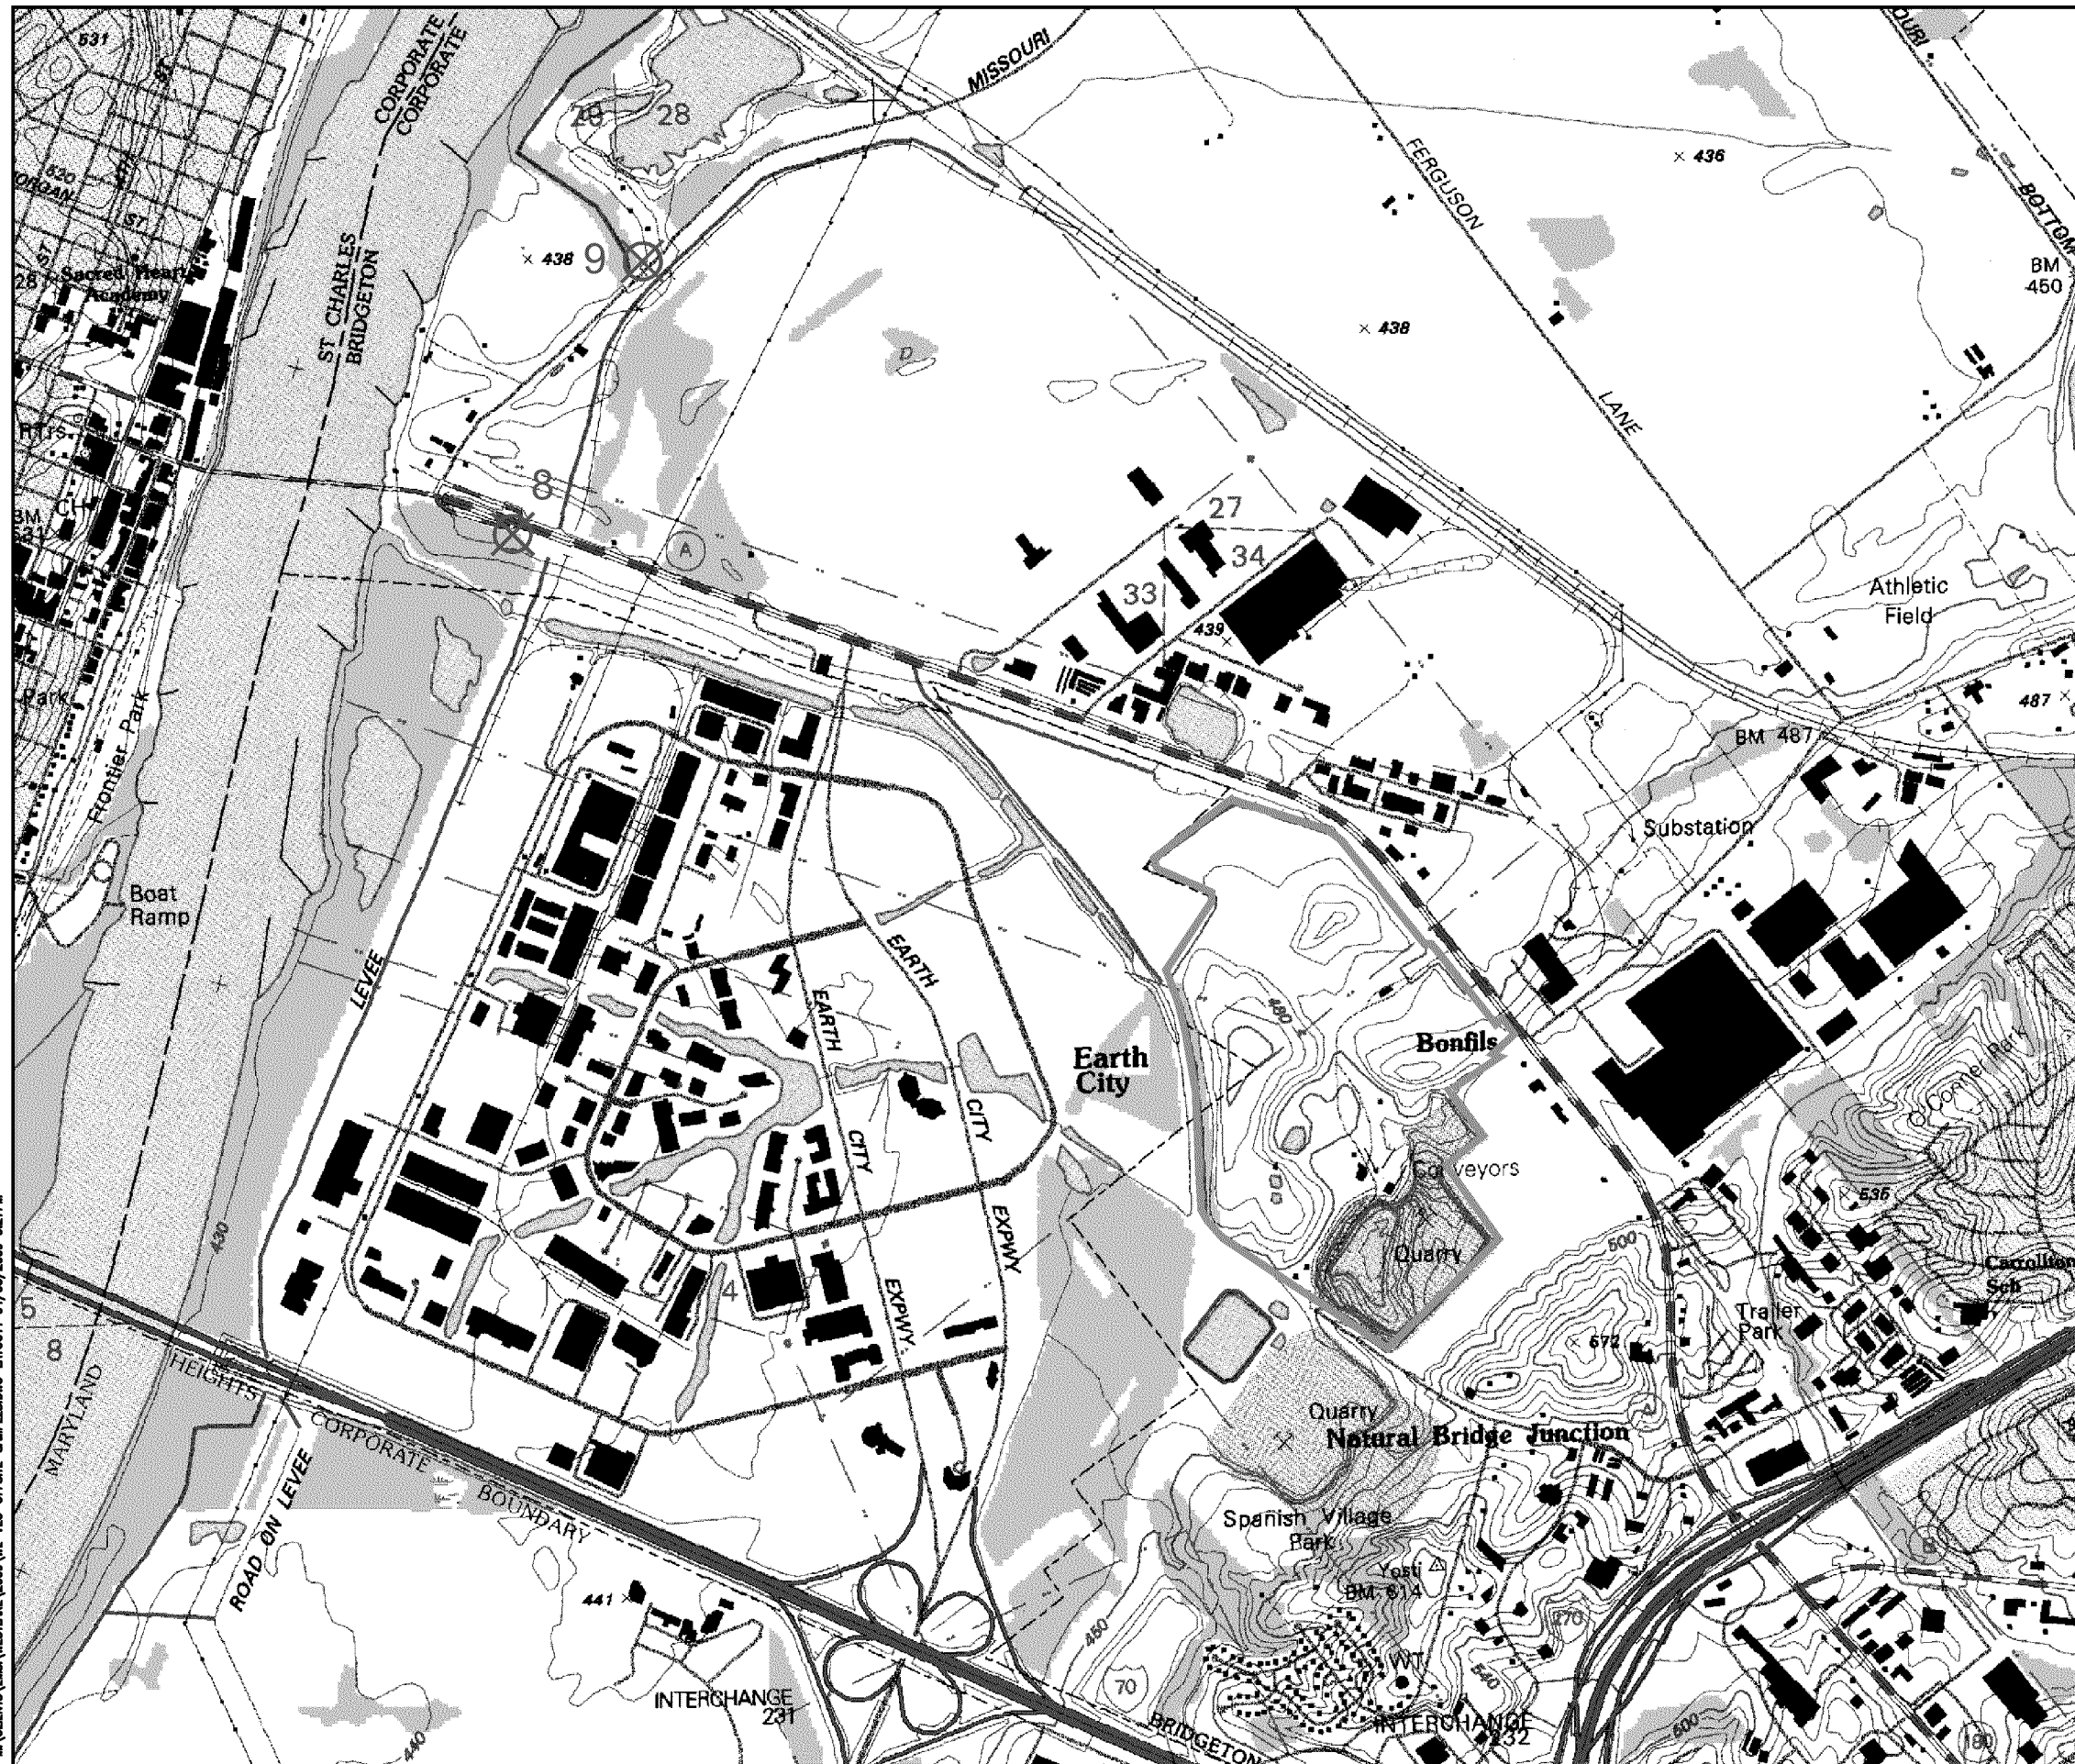
In addition to the collection of samples from areas with low gamma values within Areas 1 and 2, two vegetation background samples were taken from outside of Areas 1 and 2. Figure 2 shows the background sample locations in relation to the West Lake Landfill site. These background samples are numbered 8 and 9 on Table 1 (Vegetative Sampling Results). The background samples were collected along the Missouri River at the end of St. Charles Rock Road.
